September 23, 2020

City of Kodiak  
Office of the Harbor Master  
Attn: Michael Sarnowski  
710 Mill Bay Road  
Kodiak, AK 99615

Subject: **Limited Hazardous Material Survey of Suspect Materials – M/V Wild Alaskan**

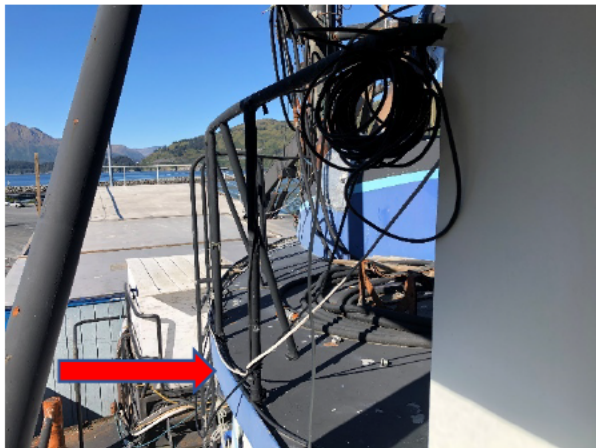
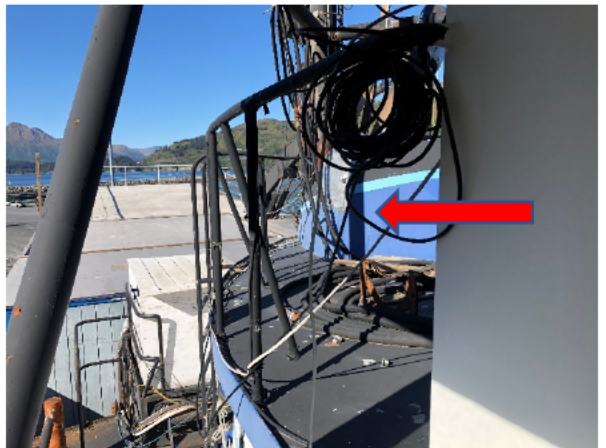
Sample 241	Stairs from Pilot to Deck, Blue Trim	Sample 242,287, 288	Stairs from Pilot to Deck, Blue Wall, and Exhaust Hood

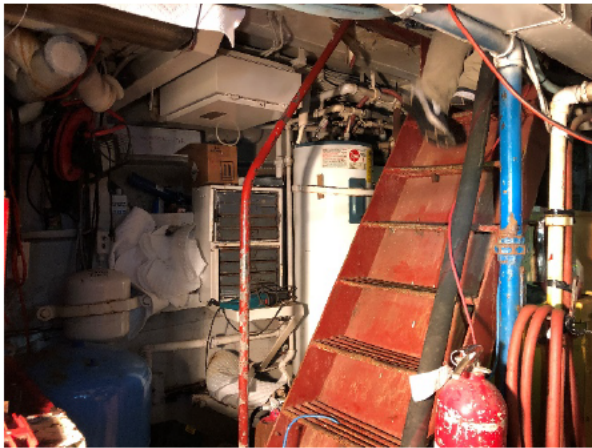
Sample  
253,255

Engine Room Stairs, Red Stairs

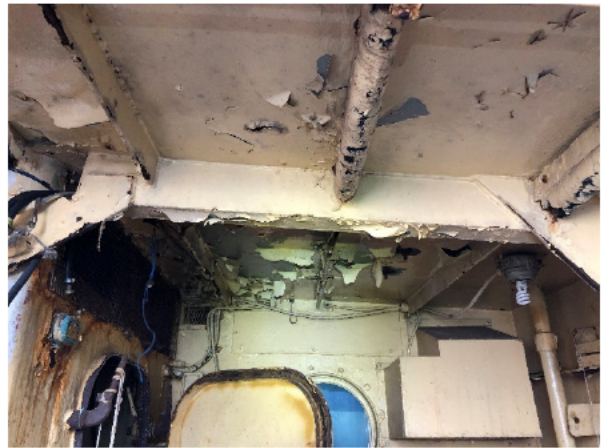
Sample  
213-215

Hydraulic Control Room

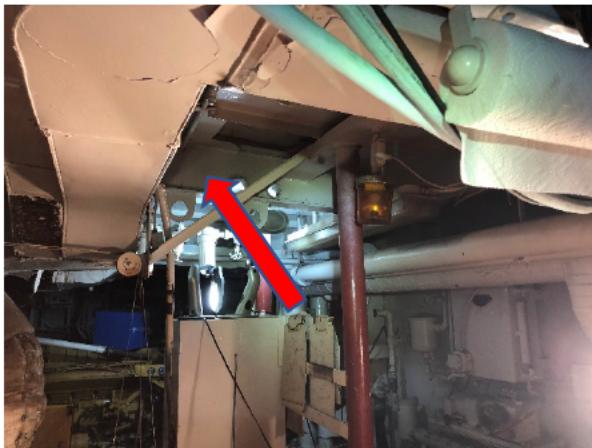
Sample  
257,259,

Engine Room, White on  
Structural Components

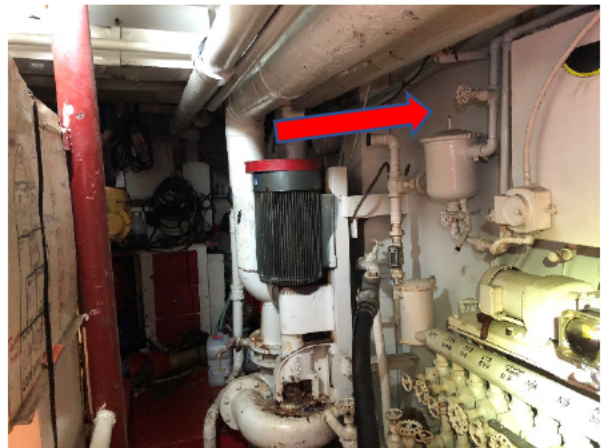
Sample  
260,261,  
276

Engine Room, White on Structural  
Components, Bulkhead

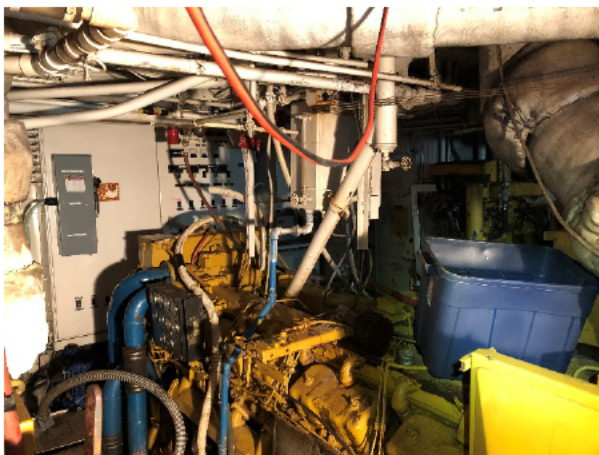
Sample  
265,266

Engine Block - Exhaust Assembly,  
Yellow

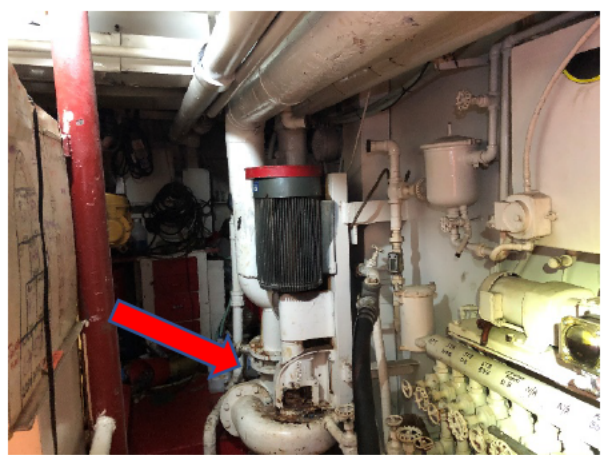
Sample  
270,273

Engine Room, White Pipe Valve  
Flange

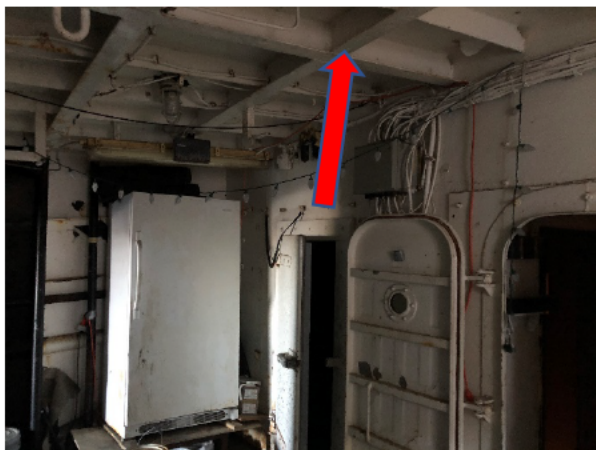
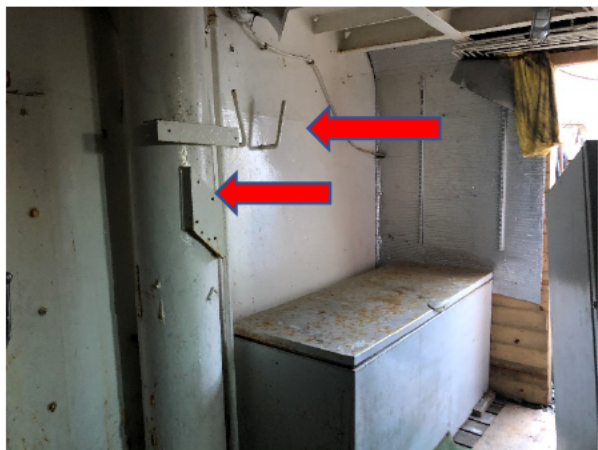
Sample 208	Freezer Room-Structural Components	Sample 205,206	Freezer Room-Vertical Pillar and Wall
